3.8 ENVIRONMENTAL HEALTH

- Phase I Environmental Site Assessment (ESA) and Asbestos-containing Building Materials and Lead-based Paint Surveys for Park Lake Homes¹

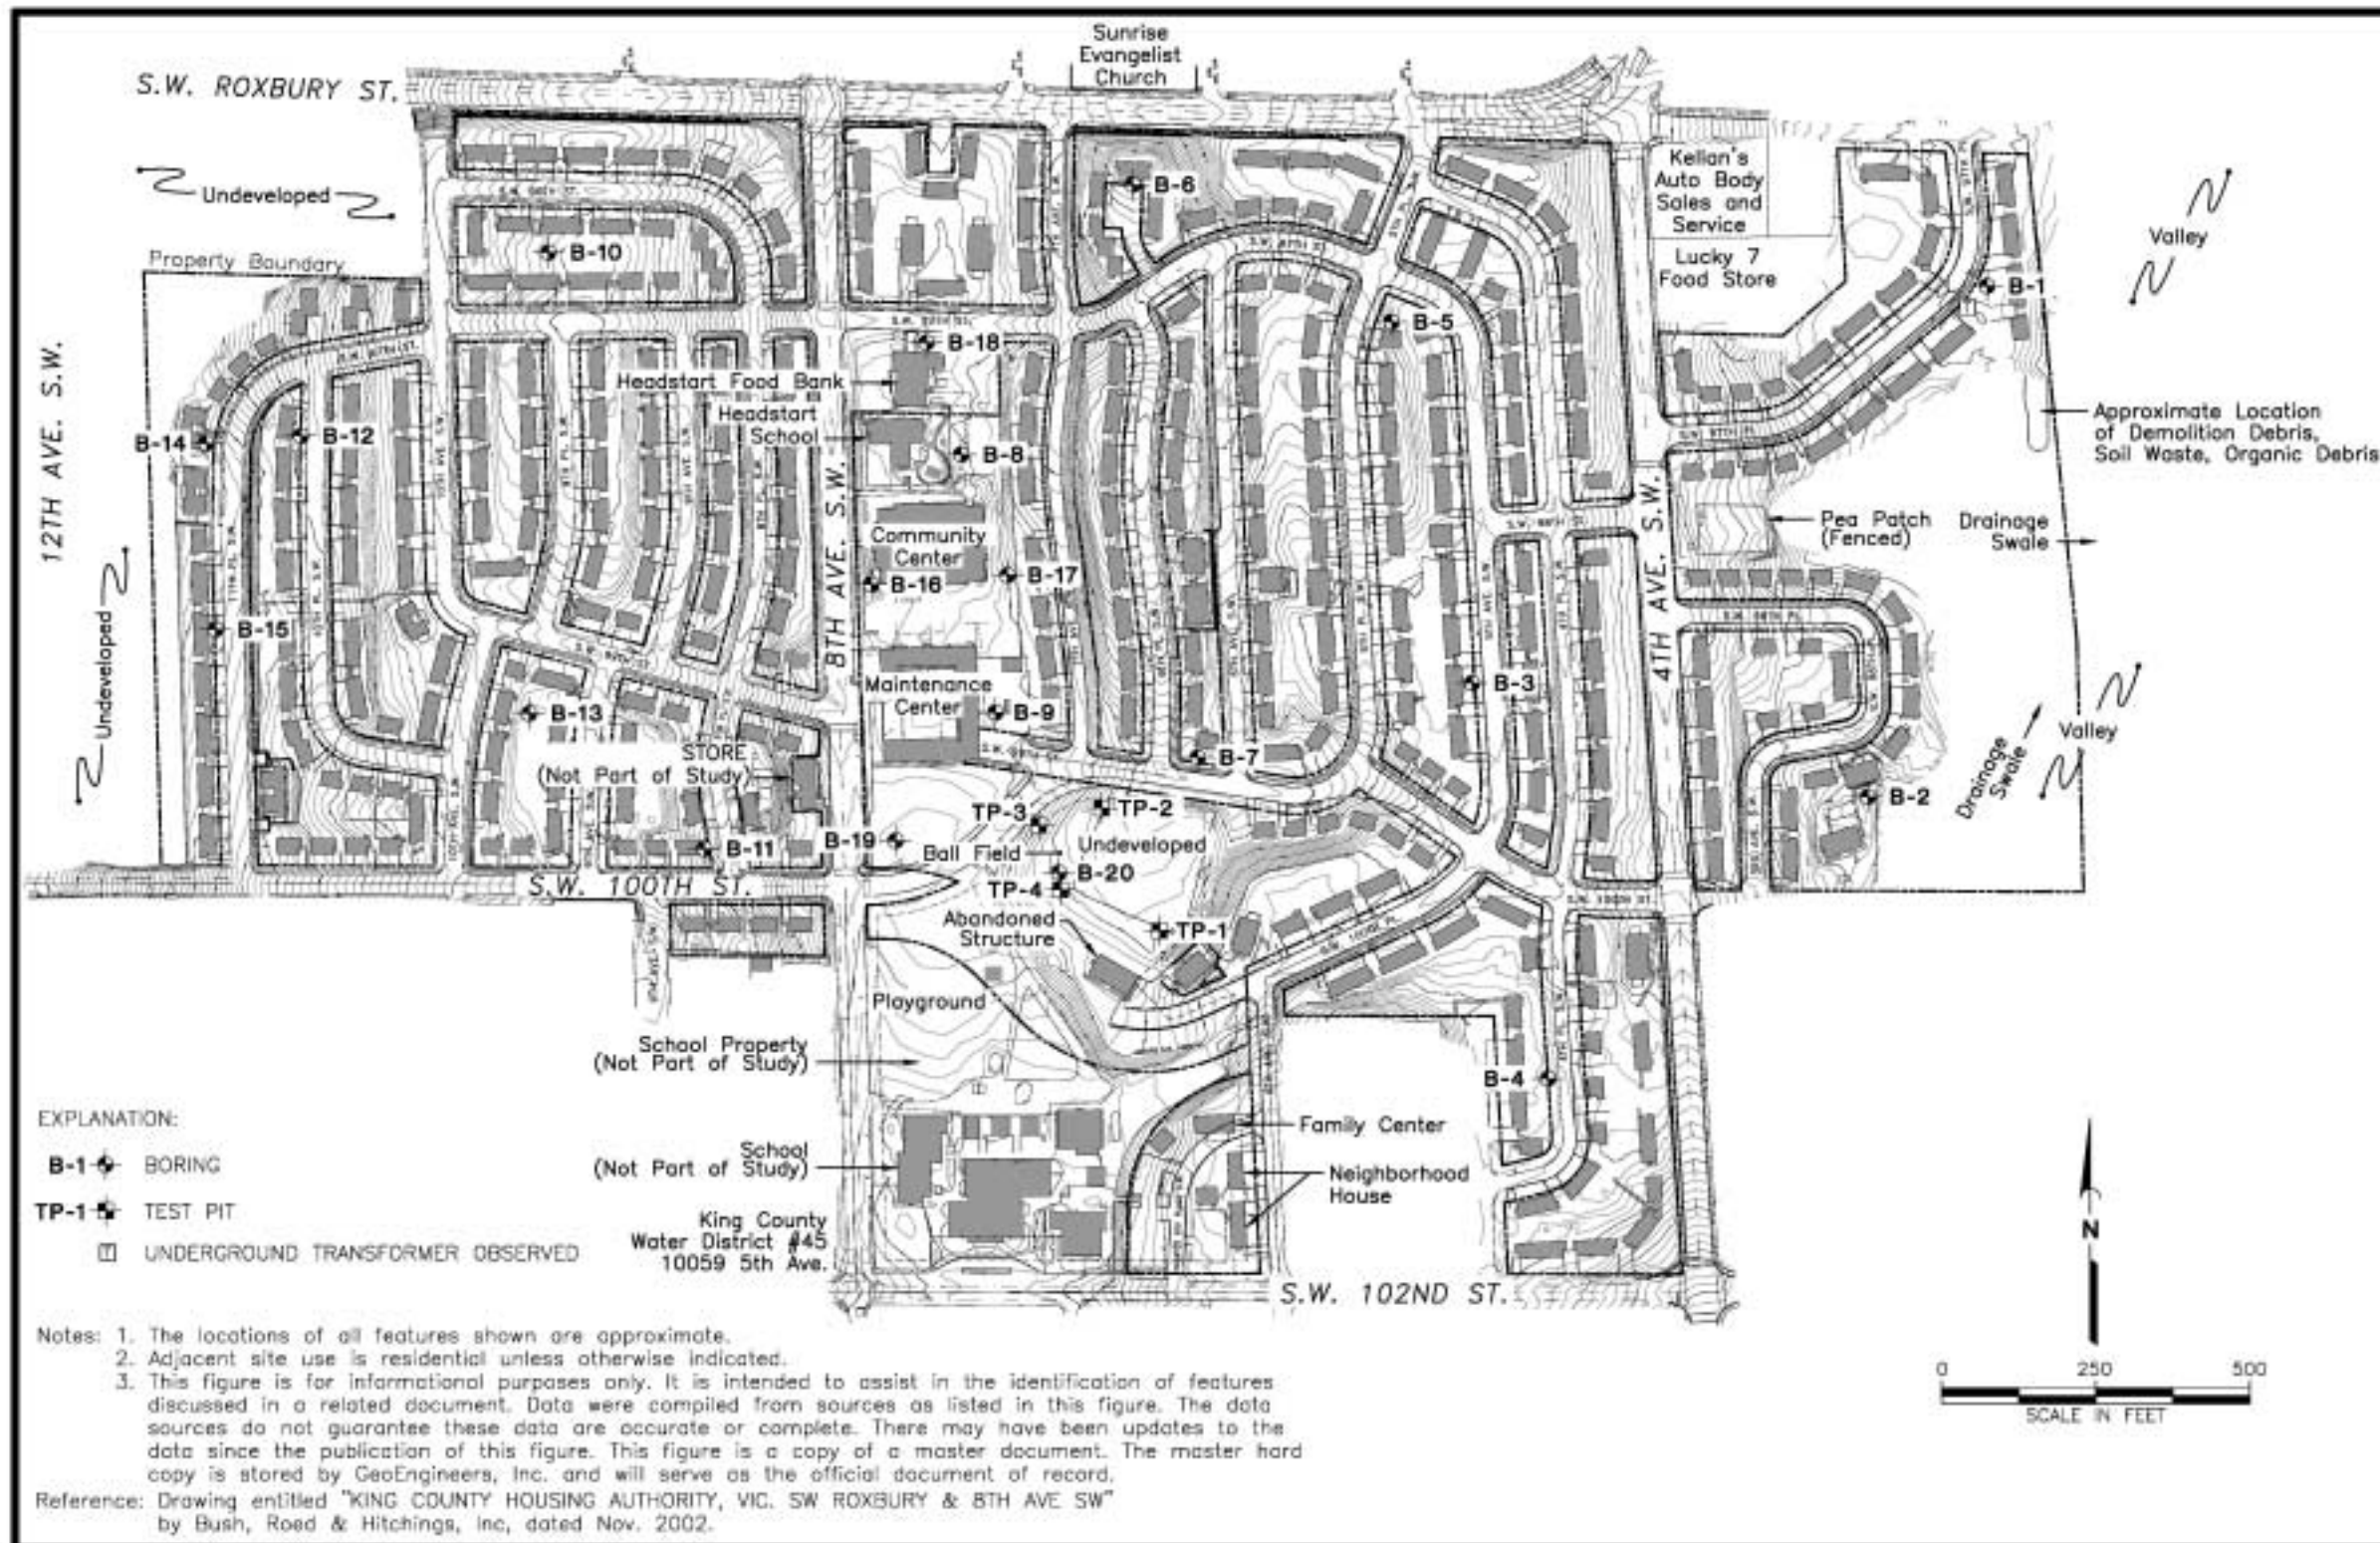
Figure 3.8-1 identifies the relevant buildings and adjacent properties addressed by the Phase I ESA.
